Report of the review into the abandoning of “Walawala 2” on the Audi Hong Kong Vietnam Race on 18 October 2013.

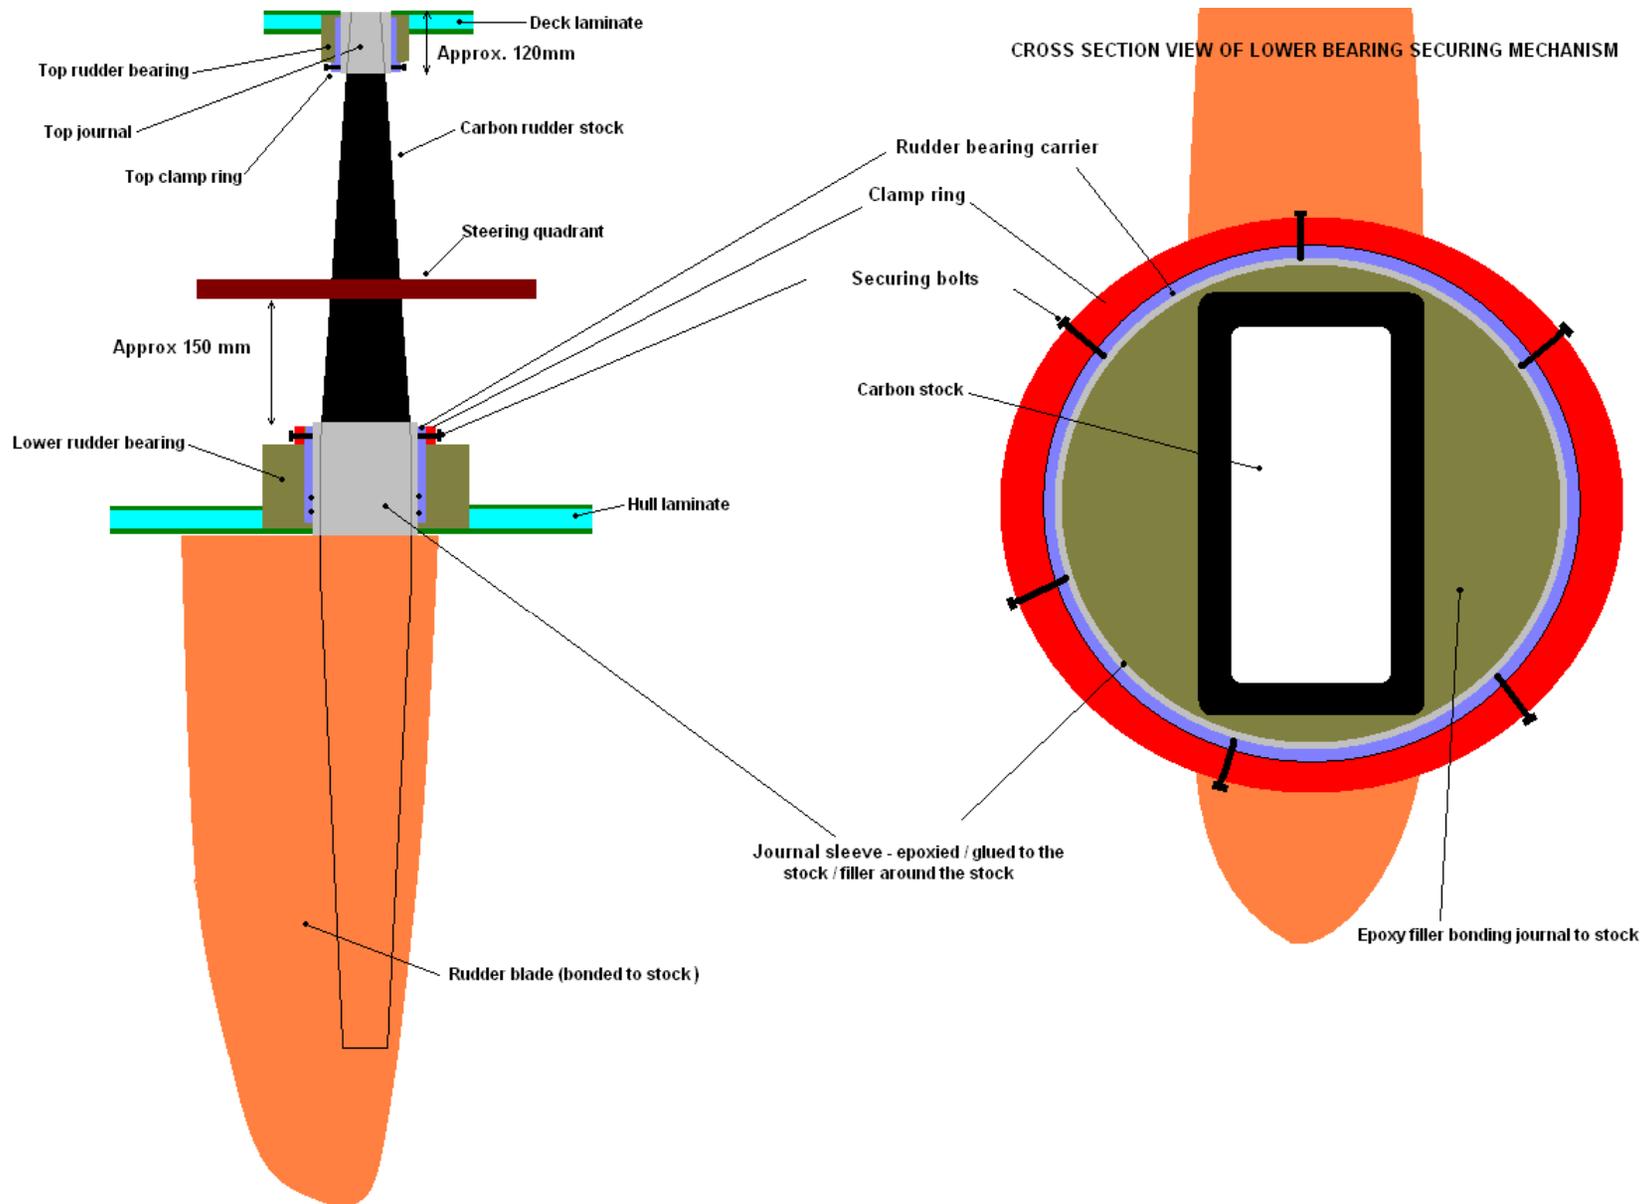
APPENDIX A - Sketch of Rudder Installation (not to scale)

Note: A visual representation of the arrangement of the Sydney GTS 43 rudder stock, quadrant and bearings is appended at Appendix A to facilitate description.

- 5.3.4 That there was a failure in the retaining system securing the rudder into the boat that then allowed the rudder and rudder stock to drop down through the bottom bearing and become disengaged from the top bearing. The steering quadrant attached to the rudder stock would have prevented the rudder from dropping completely out of the boat. The top of the rudder blade may then have punctured the hull and wrenched the lower bearing as the bearing became the fulcrum around which the rudder gyrated. This is consistent with the reports from the crew regarding the nature of damage and angle and position of the rudder stock at the time of the incident.

Note: On the Sydney GTS 43 there are a combination of bolts and grub screws at both the upper and lower rudder bearings that clamp the rudder stock (via rudder journal sleeves that are bonded to the carbon fiber rudder stock) directly to the aluminium rudder bearing carriers.

Of the possible causes by the review panel, this is considered the most probable.
